BUDGET COST ESTIMATE

**In respect of:
Saltoun Parish Church, East Saltoun**

**On behalf of:
Saltoun Community Council**

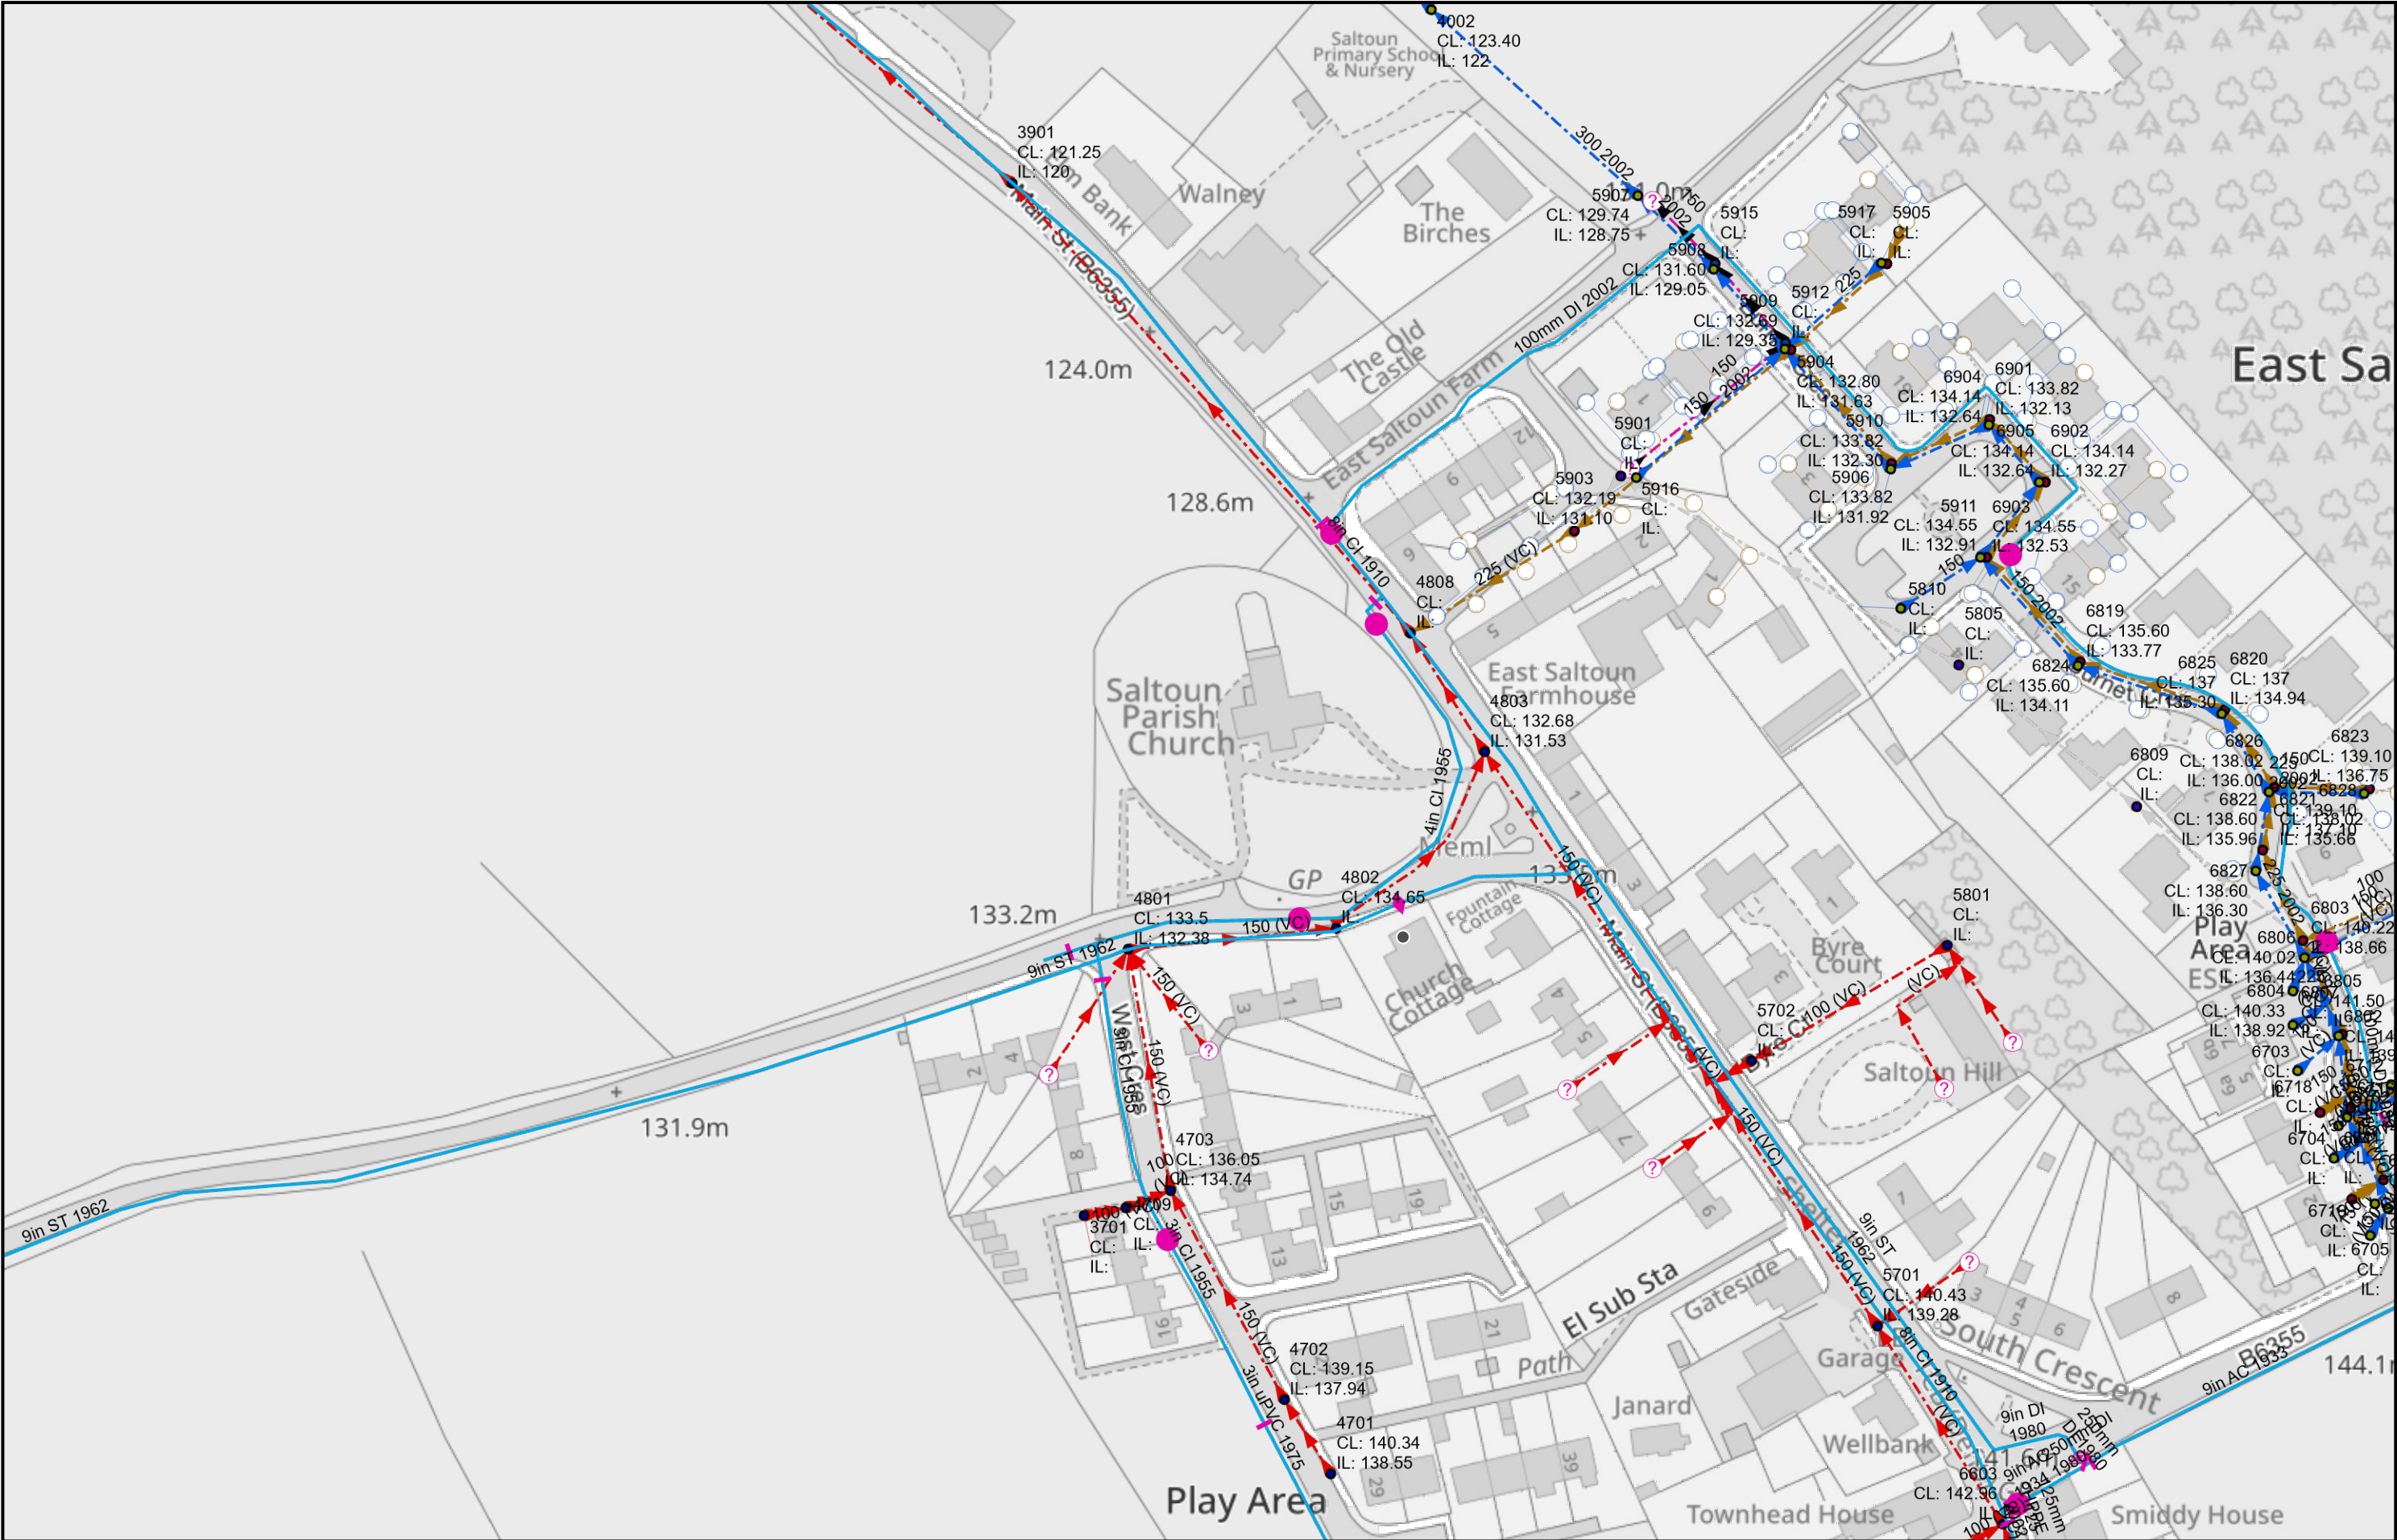
APPENDIX C – SCOTTISH WATER RECORD DRAWING

- 3.5 Record utility drawings have been obtained from Scottish Water and are included in Appendix C. Mains water supply and underground sewer pipework is shown to be routed below West Crescent and Main Street with drainage pipework leaving the village to the north-west. Scottish Water require water pipework to be installed at a minimum depth of 750mm and gravity drainage systems generally require pipework to be laid at a minimum fall of 1:80. We have estimated finished floor levels and compared them to the quoted invert levels of public manholes and drainage on the record drawings; this would indicate a suitable fall could be achieved for drainage pipework to leave the site from the building in an easterly direction below the main path to the junction of West Crescent and Main Street, where mains connections could be made within the

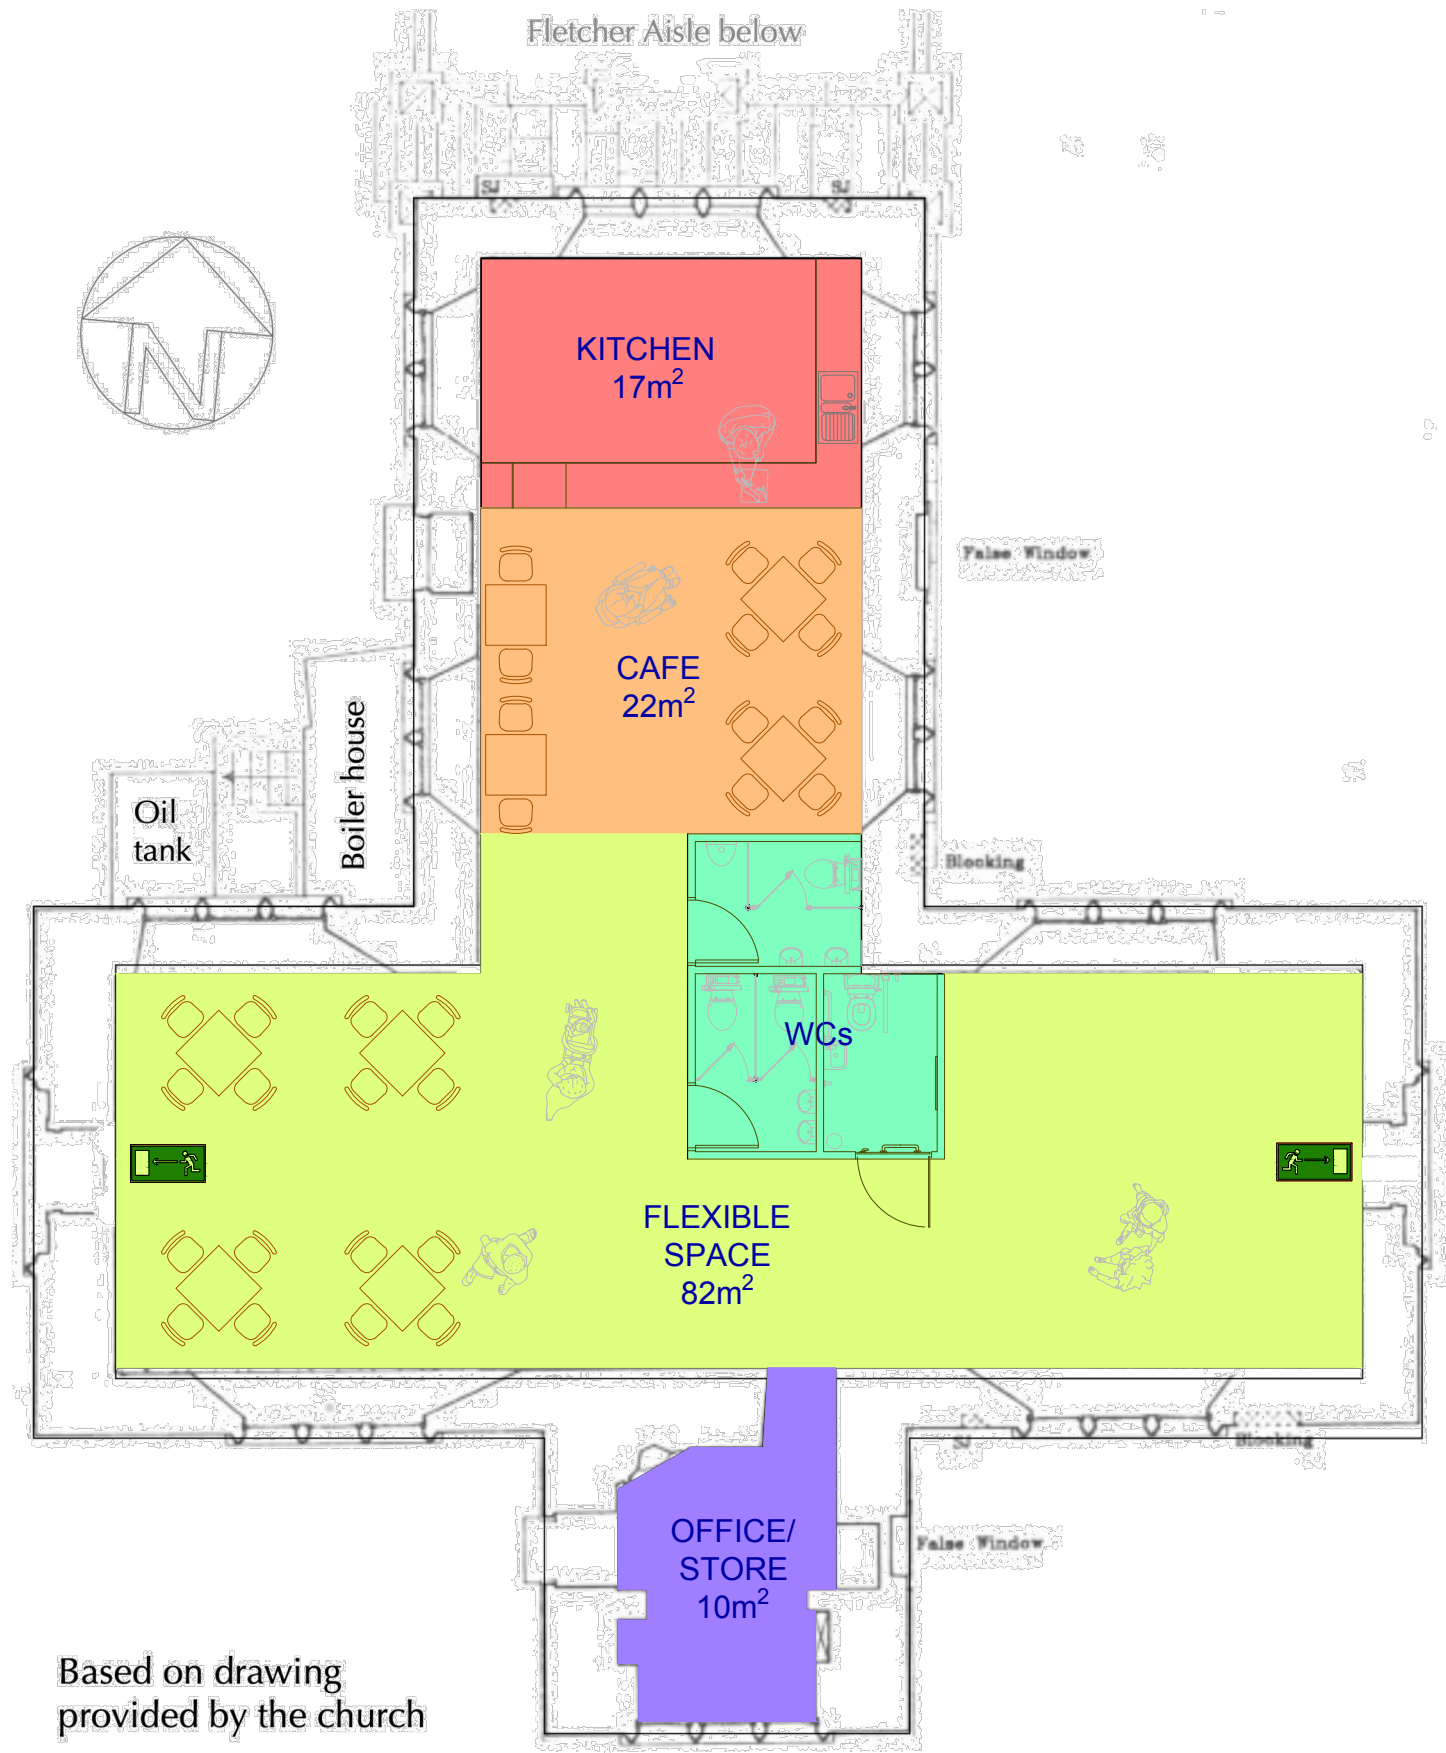
APPENDIX D – SURVEYING SOLUTIONS DRAFT LAYOUT PROPOSAL

- 3.2 We have prepared a very basic zoned outline floorplan to broadly assess likely occupancy levels and the level of toilet accommodation they would require; this is included in Appendix D. The plan is based on the existing floorplan contained within the provided Quinquennial report and while check measurements were taken on-site which agree with the dimensions noted, no detailed measured building survey was undertaken. We have illustrated an area to provide a kitchen / café to the north end of the nave assuming internal part height partitions at the junction of the nave and the transept to form new toilet facilities, a location and configuration chosen so as not to divide window openings and minimise construction cost and impact on the building. Our drawing is for basic feasibility purposes only and no assumptions should be made regarding the viability or likelihood of achieving Listed Building Consent, Planning Permission or Building Standards approval.
